SIGIR INSPECTIONS

Project Assessments: Findings at a Glance

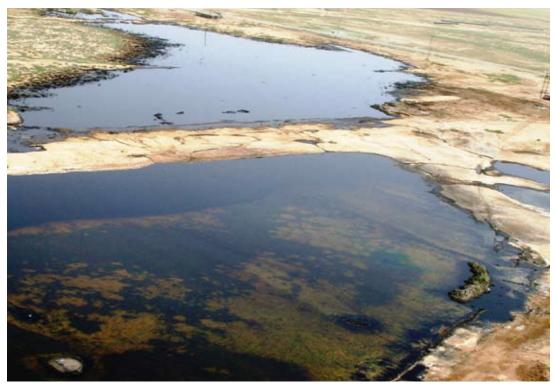
Aerial view of oil leakage along the existing Kirkuk-to-Baiji Pipeline

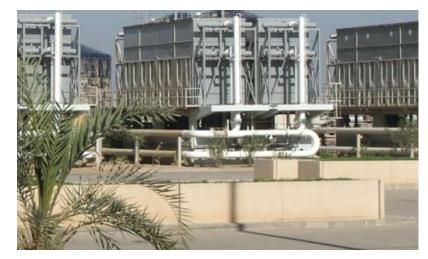
site assessment. The water treatment facility, which generates the required processed water for the HVAC systems and potable water for the airport, was not operational at the time of the assessment. The water treatment plant, renovated through a USAID project in 2003, had many equipment and operations issues. Upgrading the water treatment system was not included in the Basrah Tower Renovation project. Although USACE identified that "poor quality processed water places \$2.5 million of chiller work in jeopardy" in an Airport Status Meeting presentation on April 10, 2005, there was no budgeted project to repair the water

Three pairs of cooling towers for HVAC system of main passenger terminal

SIGIR recommended that GRD-PCO and IRMO develop a comprehensive, coordinated effort, including scope and funding requirements and funding requests. The effort should ensure that BIA has a functioning water treatment facility to provide potable water for the passenger terminal and processed water for the HVAC systems.

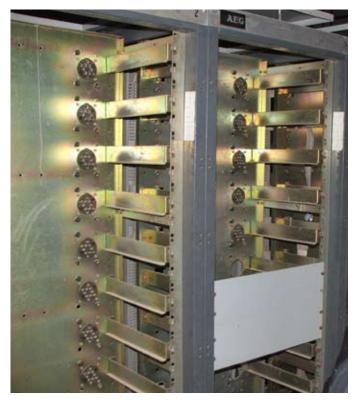
The Air Side Power Supply to Navigational Aids (NAVAIDS) and Visual Aids (VISAIDS) was a \$383,043 project at BIA. The electrical distribution systems were not operational because the systems had not been properly maintained throughout the previous regime, and the electrical systems had been damaged, looted, and cannibalized.

Missing electronic equipment at runway substation

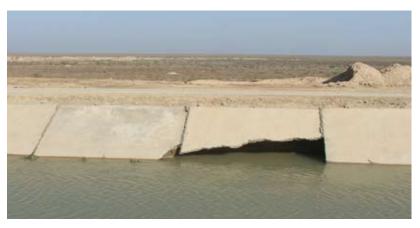
Example of under-cutting of canal

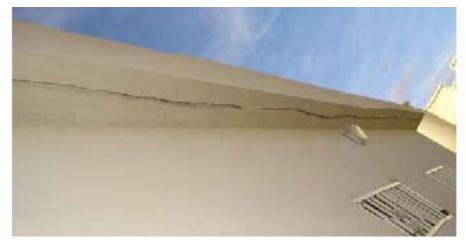
Most of the border forts had difficult access roads, especially during rain or snow. Many sites lacked retaining walls to prevent degradation of the embankments created by site leveling. The ground survey teams noted numerous cracks in the building foundations, exterior walls, and interior walls. Cracks appear to be signs of differential settling of the foundation systems, which could create structural integrity problems. In addition, signs of down-gradient slope movement were observed, caused by the lack of retaining walls.

Crack in overhang of border post

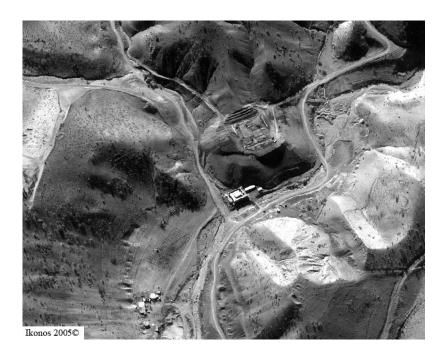
Imagery taken on December 9, 2005, shows an overview of the Bargurd border fort—Visual assessment confirms the geo-coordinate location of the Bargurd border post. A review of imagery shows what appears to be a completed and functional border post. Visible structures include border-post main building, storage building, covered parking, and generator shed. Visible problems include the lack of perimeter wall and retaining walls, which would prevent erosion and avalanche damage during snow and rain. Poor location makes this site difficult for defense and for monitoring border activities. Imagery supports the inspection team's report finding.
